Hemtack
S.A. De C.V.

ENGINEERING REPORT

REPORT TITLE:	IMPROVED HR DESIGN SLOT POSITION FOR 953/958	REPORT DATE:	08/13/2021
REPORT NUMBER:	ENGREP 047	CREATED BY:	J. Majli Jauregui Ruiz
QA & ENGINEERING APPROVAL	CC:		
Hugo Amezcuita	Lulu Montejo, Lee Hunt, Marcos Chang, Hugo Amezcuita.

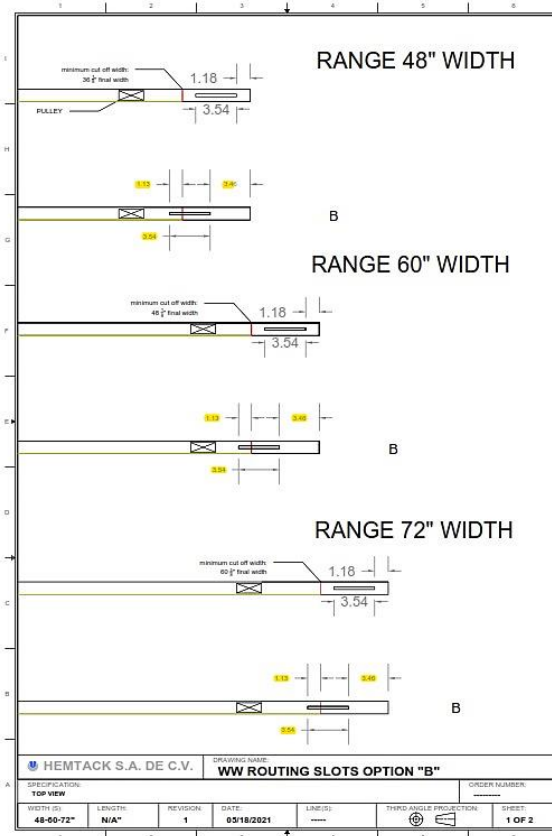
Based on an improvement proposal, a design change was requested with the objective of eliminating the need to perform the slot routing operation in the MTM production area. The proposal considers a specification change in regards of the location of the slots at each end of the woven wood shades headrail.

Figure. 1 DESIGN CHANGE PROPOSAL.

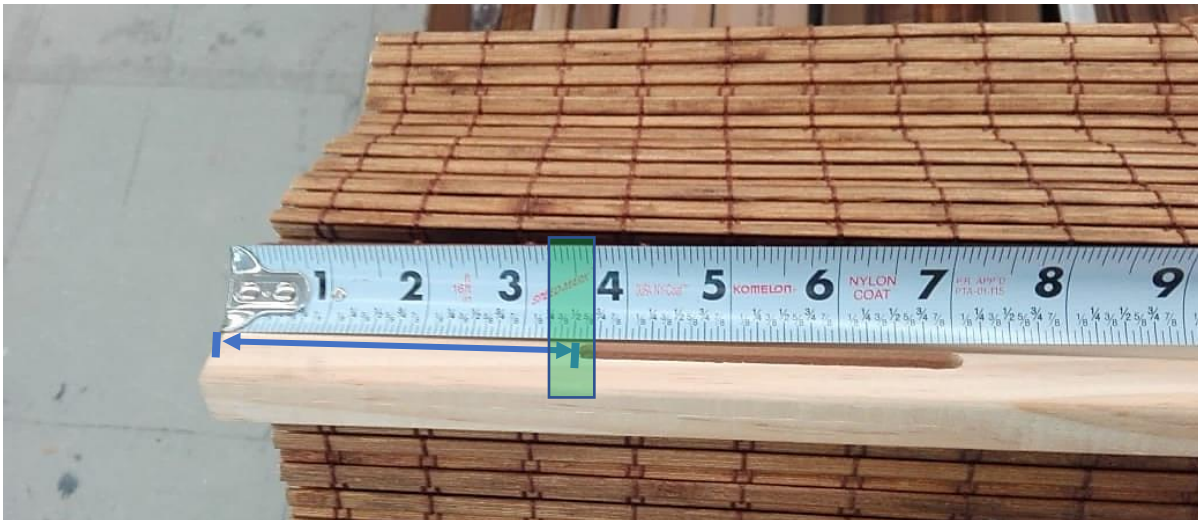
Figure. 2

CURRENT HEADRAIL DESIGN

- Specification of the current design for the 48", 60" and 72" headrail, certain width adjustment end up requiring to perform the routing operation to redo the slots, mainly because the adjustments can go up to 5 ¾" and the slot is located around 1 ¼" inwards at each end (see image 3, 4 and 5).

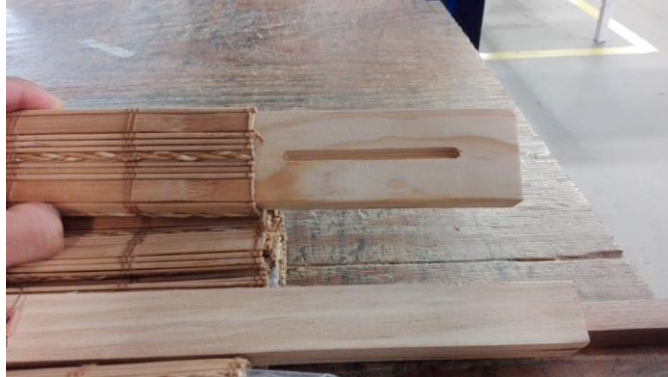
Figure. 3 Reveal after cutting the fabric trim on each side.

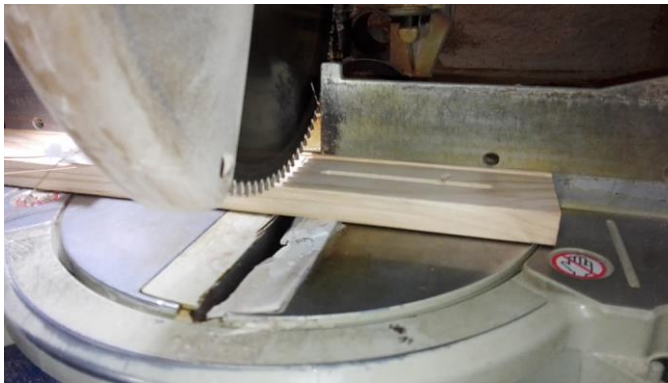
Figure. 4 Cutting action on the width of the fabric.

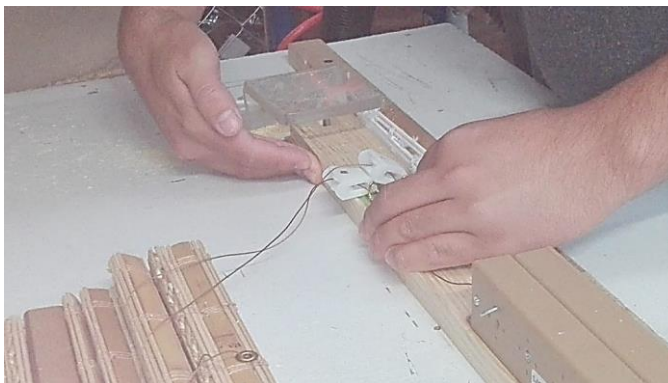
Figure. 5 Rework to recompose the slots to make assembly possible.

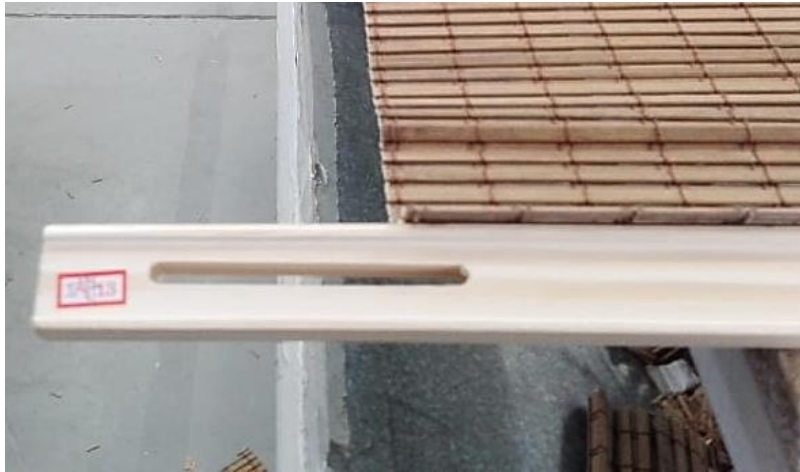
After performing the headrail cutoff operation, we can see that the slot still runs about 1 1/8" which is sufficient to allow for installation of the mounting hardware (brackets). No additional routing is required to extend the slots.

Figure. 6 Fabric adjustment to the maximum possible based on the width ranges.

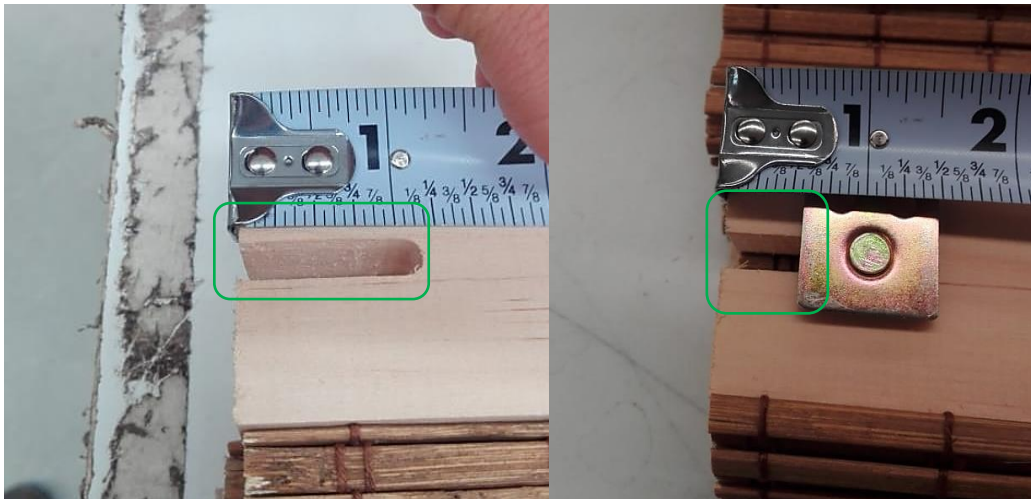
Figure. 7 left side end view of the slot, right side example of the positioning at the ends.

- As shown in figure 7, there is no interference with the position of the mounting hardware (bracket) and the returns in the case of outside mount shades.
- The formal change request will be submitted through an Engineering Change Order.
